**STAFF REPORT 08-14-2019 REGULAR MEETING**  
**APPLICATION NUMBER:** 19-6371  
**ADDRESS:** 2444 SEMINOLE STREET  
**HISTORIC DISTRICT:** INDIAN VILLAGE  
**APPLICANT:** EMMALYN HELGE  
**STAFF SITE VISIT:** 08-02-2019

### **PROPOSAL**

With the current proposal, the applicant is seeking the Commission's approval **to remove the existing light tan paint from all brick and repaint with faux brick paint scheme per the attached application**. Included in the proposal are the following scope items:

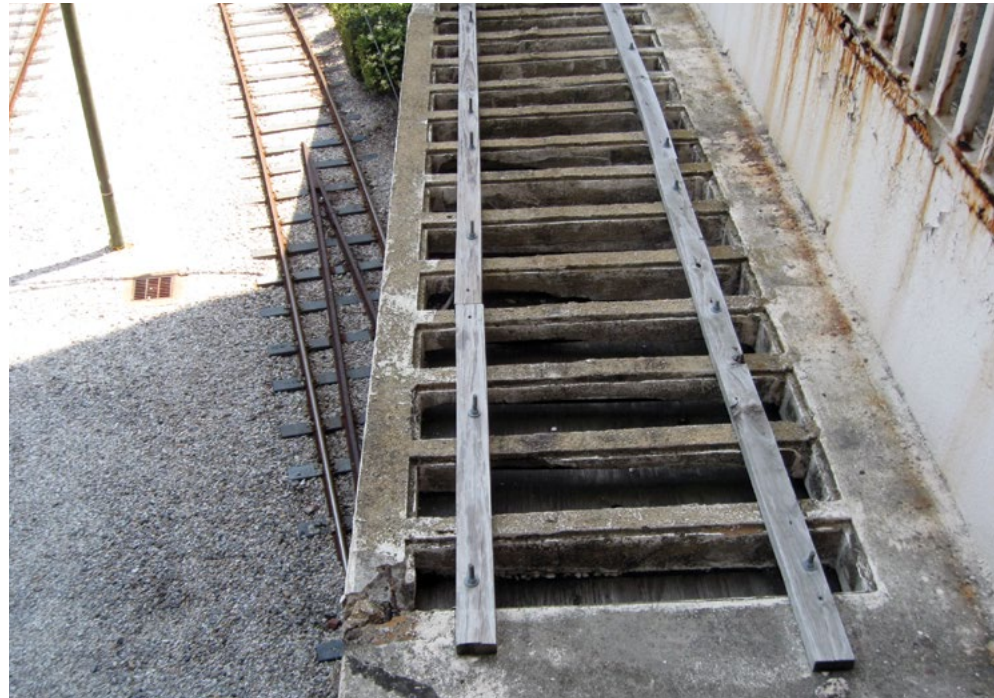
[6] Some areas of the concrete brise soleil screen on this building constructed in 1967 are badly deteriorated. If the screen cannot be repaired, it may be replaced in kind or with a composite substitute material with the same appearance as the concrete.

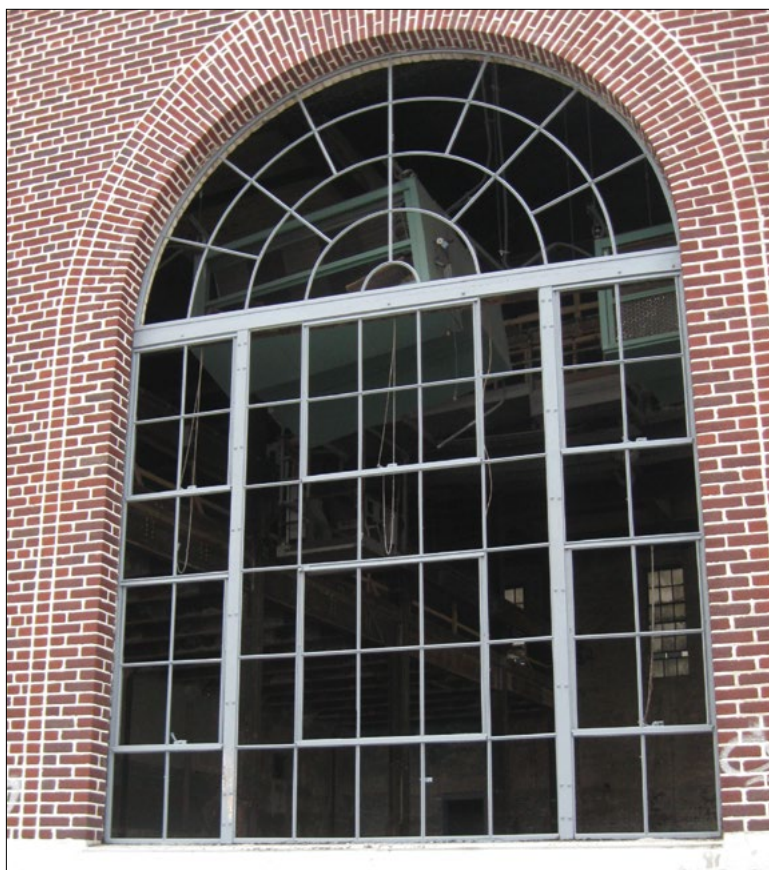
[12] This historic steel window has been cleaned, repaired, and primed in preparation for painting and reglazing.

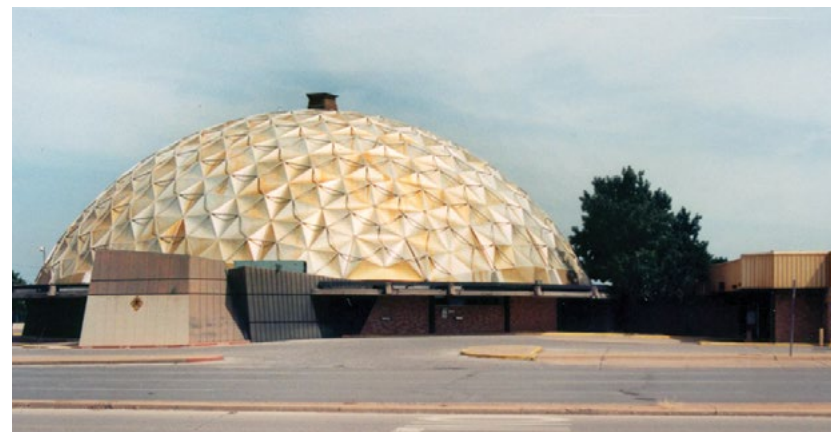
[13] The gold-colored, anodized aluminum geodesic dome of the former Citizen's State Bank in Oklahoma City, OK, built in 1958 and designed by Robert Roloff, makes this a distinctive mid-20th century building.

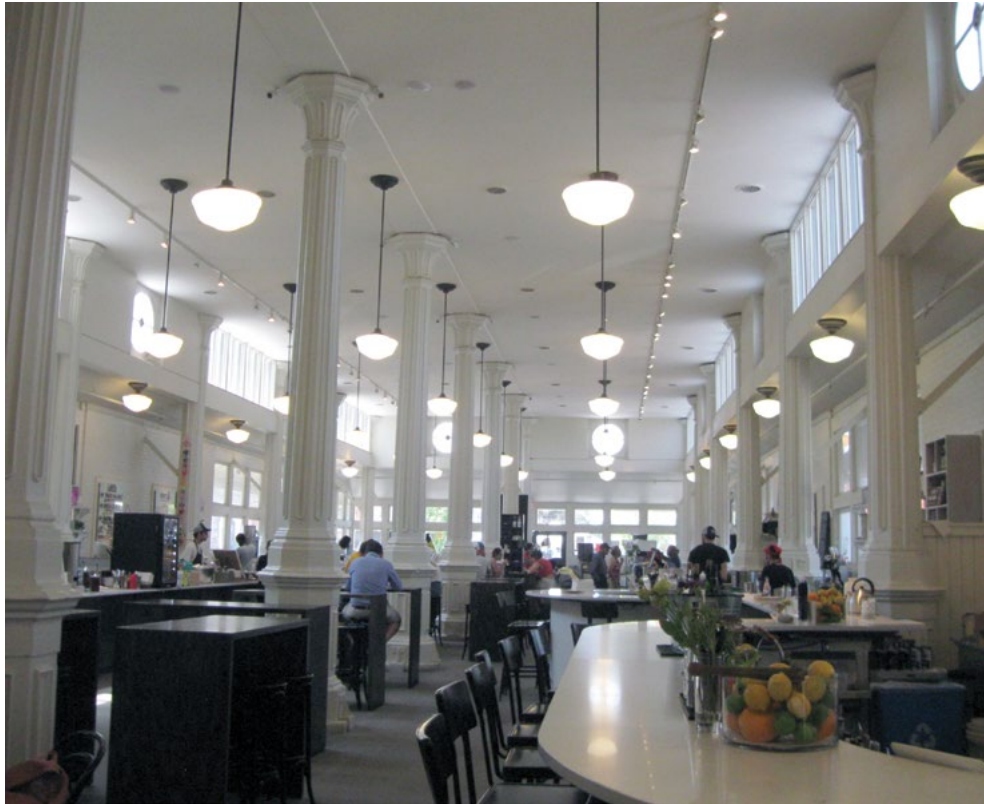
[14] Interior cast-iron columns have been cleaned and repainted as part of the rehabilitation of this historic market building for continuing use.

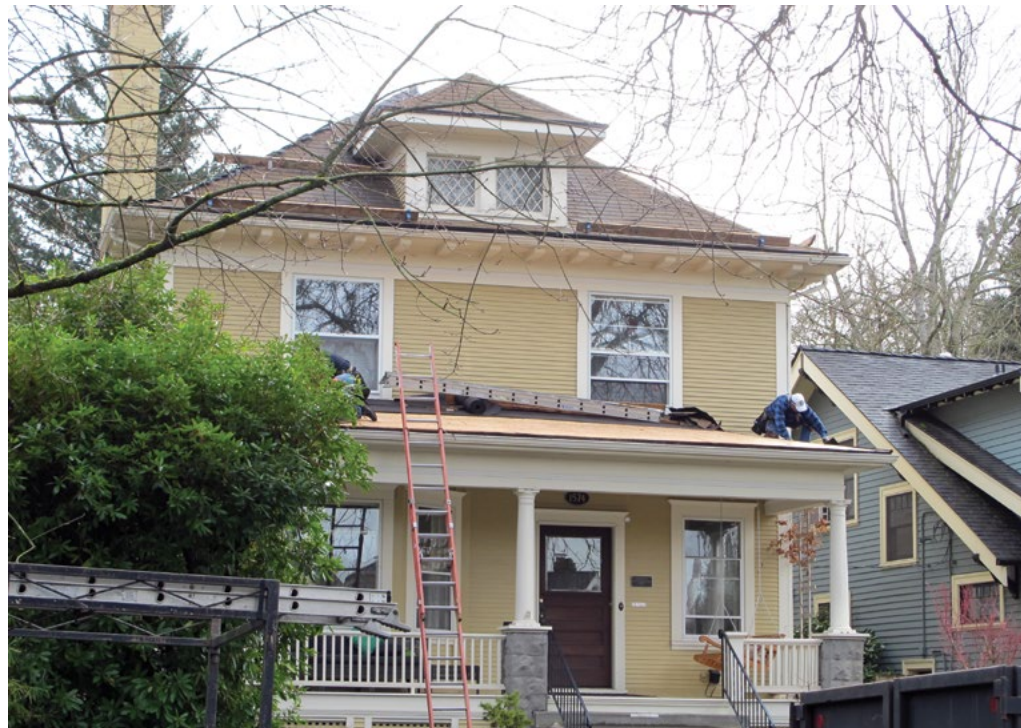
[16] The deteriorated asphalt shingles of this porch roof are being replaced in kind with matching shingles.

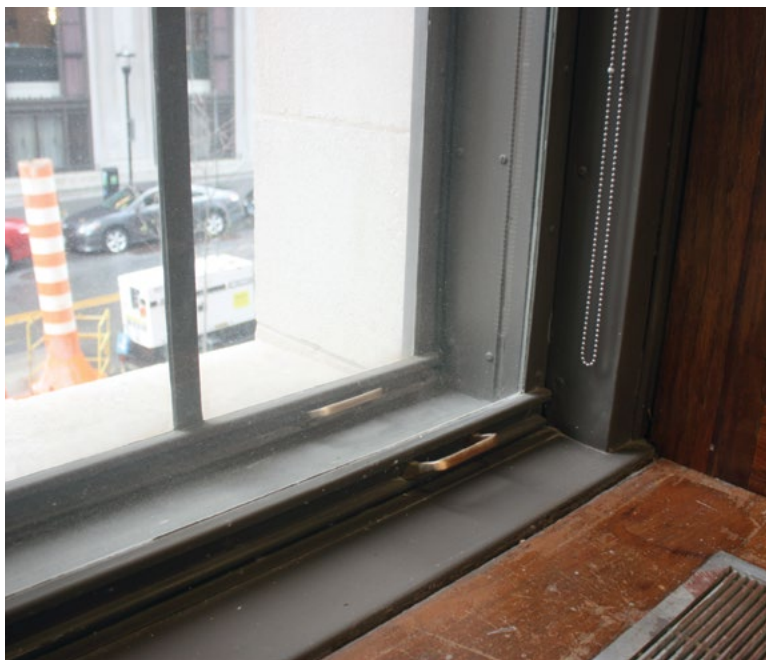
[18] The historic metal storm windows in this 1920s office building were retained and repaired during the rehabilitation project.

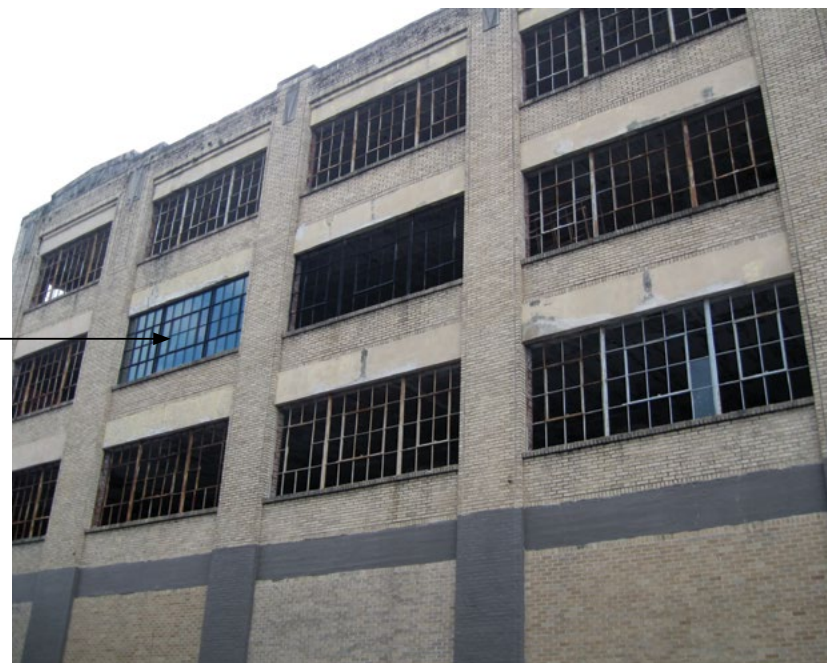
[19] Installing a mockup of a proposed replacement window can be helpful to evaluate how well the new windows will match the historic windows that are missing or too deteriorated to repair.

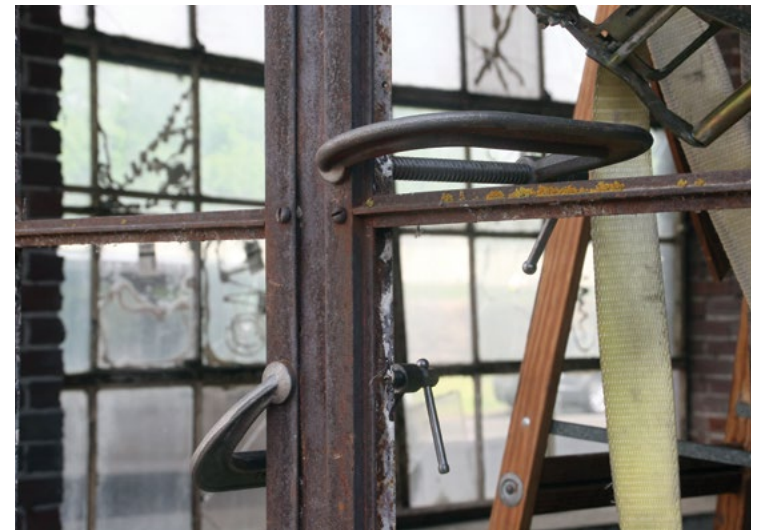
[20 a-d] The original steel windows in this industrial building were successfully repaired as part of the rehabilitation project (left).

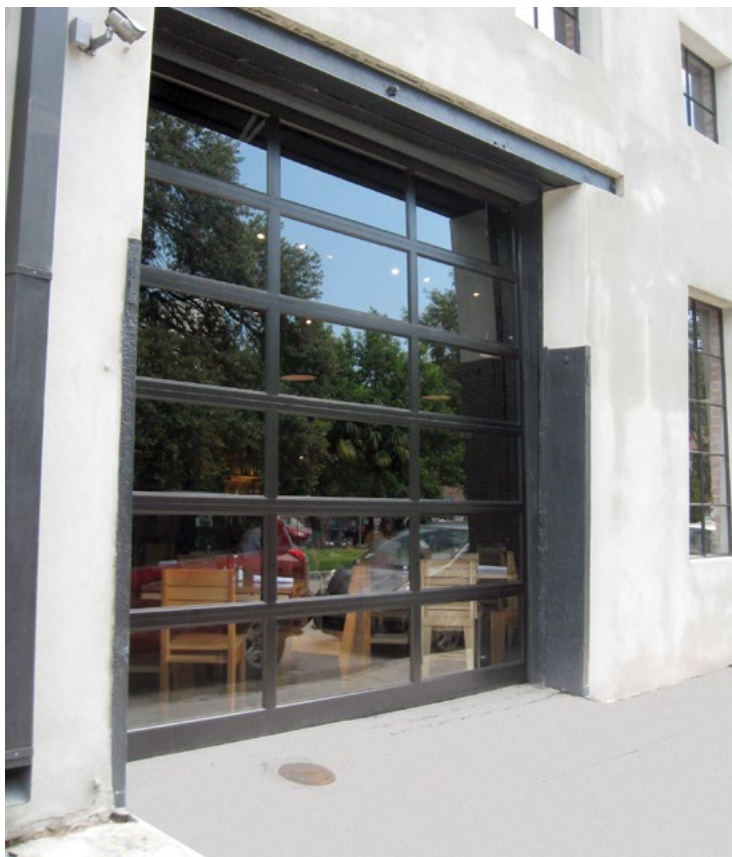
[25] The new infill designs for the garage door openings in this commercial building (a) converted for restaurant use and in this mill building (b) rehabilitated for residential use are compatible with the historic character of the buildings.

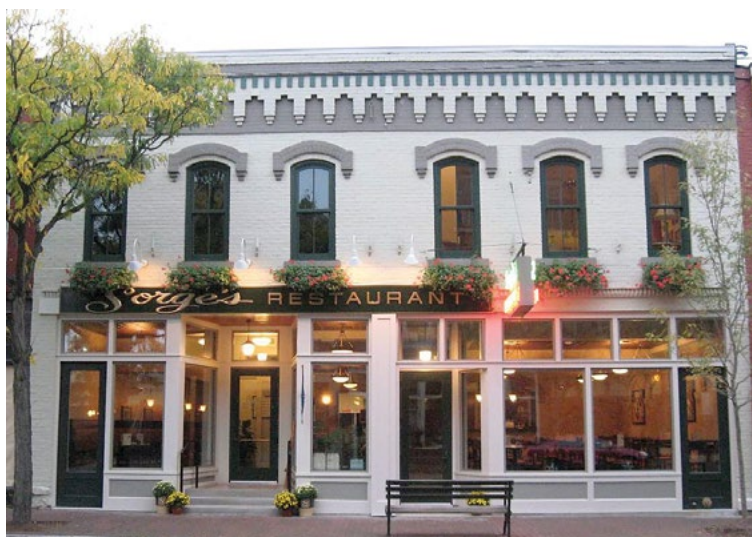
[28] This new storefront, which replaced one that was missing, is compatible with the historic character of the building.

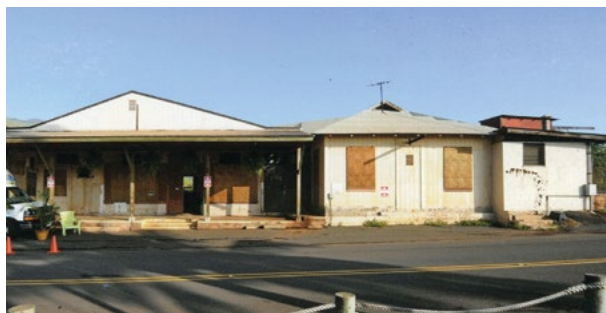
[29] The rehabilitation of the 1910 Māālaea General Store (a), which served the workers' camp at the Wailuku Sugar Company on the Hawaiian island of Maui, included the reconstruction of the original parapet (b).

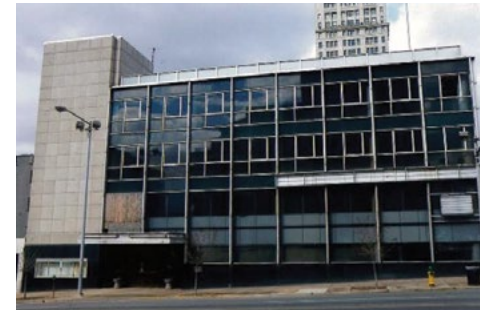
[31 a-c:] (a) The rehabilitation of the First Federal Savings and Loan Association building in Birmingham, AL, constructed in 1961, required replacing the deteriorated historic curtain wall system because the framing and the fasteners holding the spandrel glass and the windows had failed. (b) Comparative drawings show that the differences between the replacement system, which incorporated new insulated glass to meet wind-load requirements, and the original system are minimal. (c) The replacement system, shown after completion of the project, has not altered the historic character of the building.

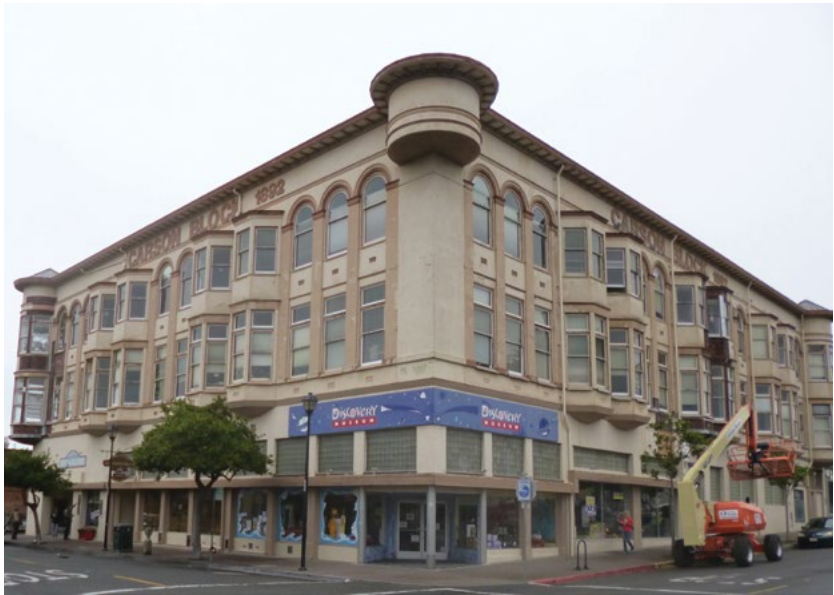
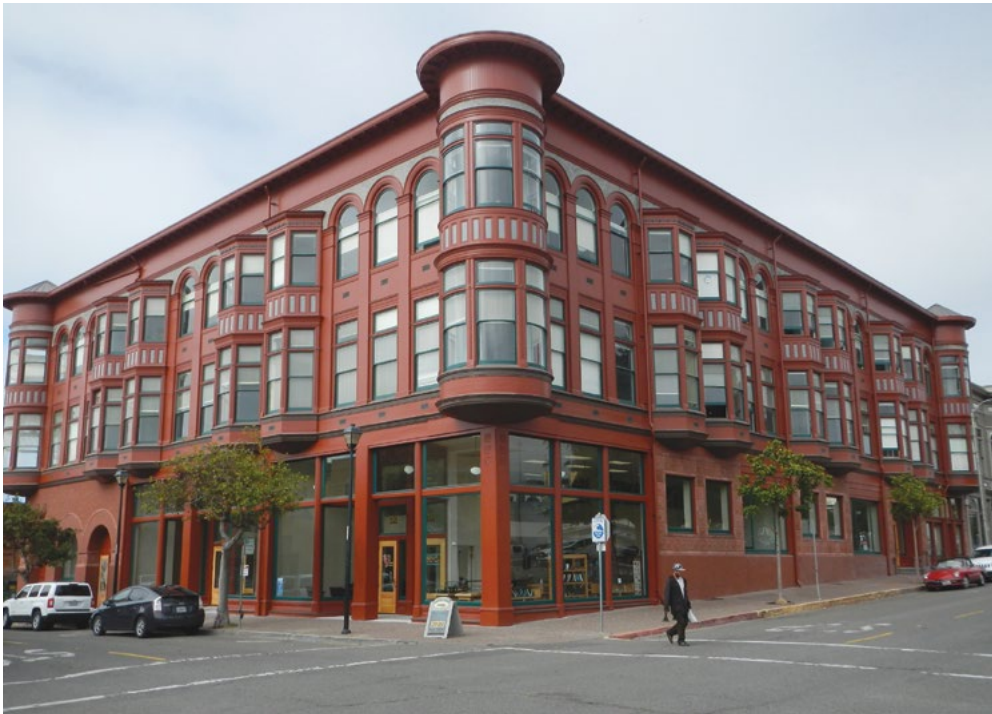
[32] (a-b) The rehabilitation of the 1892 Carson Block Building in Eureka, CA, for its owner, the Northern California Indian Development Council, included recreating the missing corner turret and sensitively introducing seismic reinforcement (c) shown here (opposite page) in a secondary upper floor office space. Photos: Page & Turnbull.

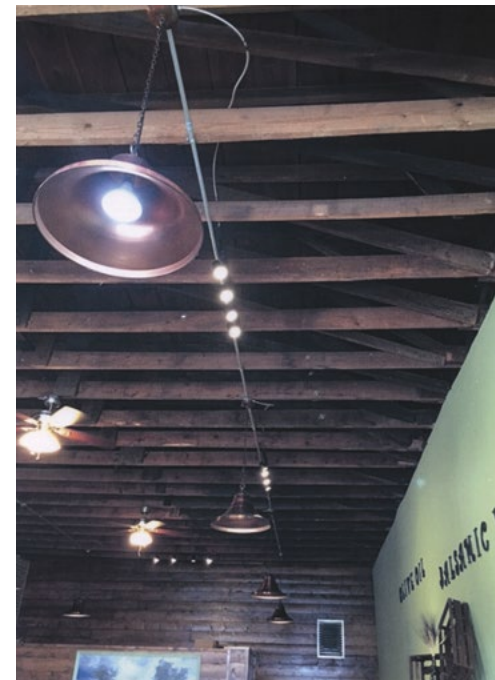
[40] **Not Recommended:** Removing a finished ceiling and leaving the structure exposed in a historic retail space does not meet the Standards for Rehabilitation.

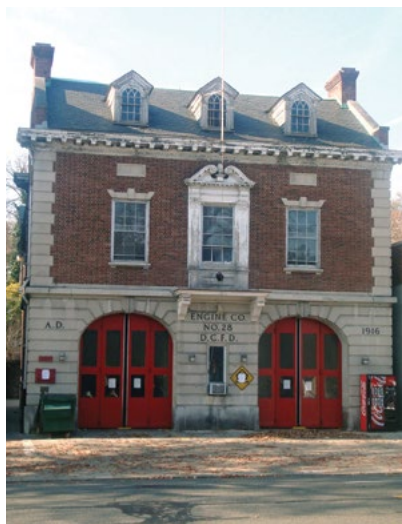
[56 a-b] In order to continue in its historic use, the door openings of this 1916 Colonial Revival-style fire station had to be widened to accommodate the larger size of modern fire trucks. Although this resulted in some change to the arched door surrounds, it is minimal and does not negatively impact the historic character of the building. (a) Above, before; Photo: Fire and Emergency Medical Services Department (FEMS), Washington, D.C.; below, after.

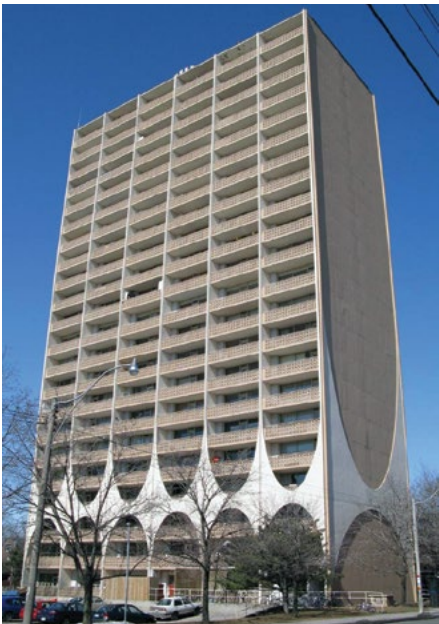
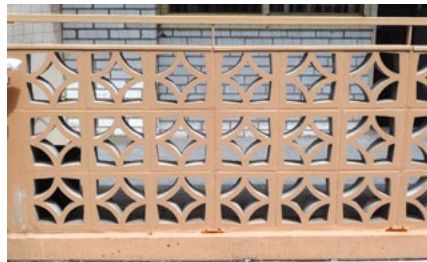
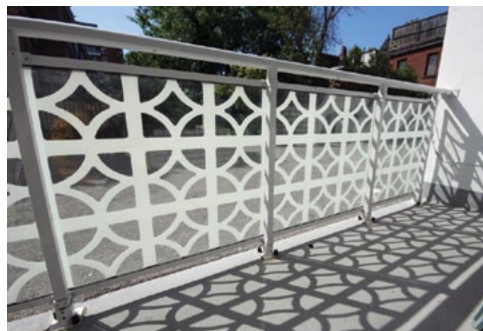
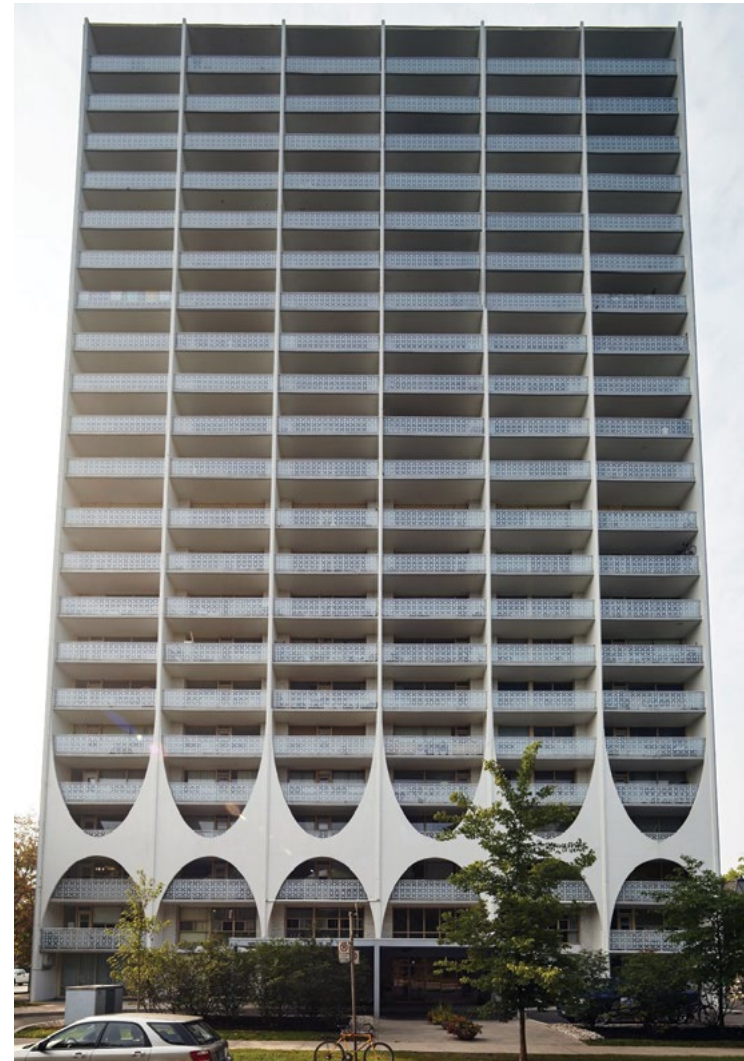
[59] (a-b) The decorative concrete balcony railings on this 1960s building did not meet life-safety code requirements. They were replaced with new glass railings with a fritted glass pattern matching the original design—a creative solution that satisfies codes, while preserving the historic appearance of the building when viewed from the street (c-d). Photos: (a, b, d) ERA Architects, Inc.; (c) Nathan Cyprys, photographer.

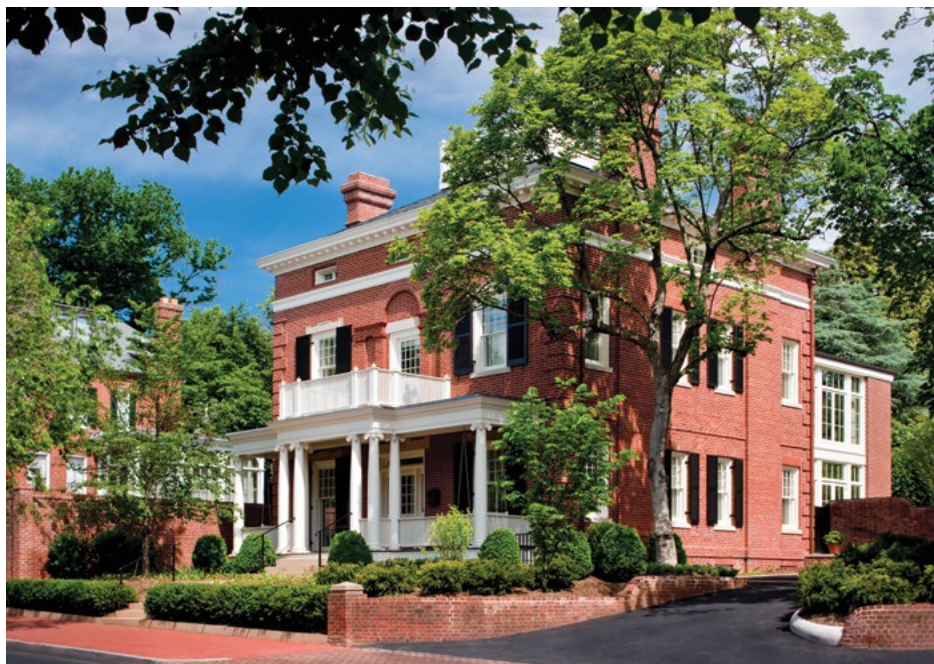
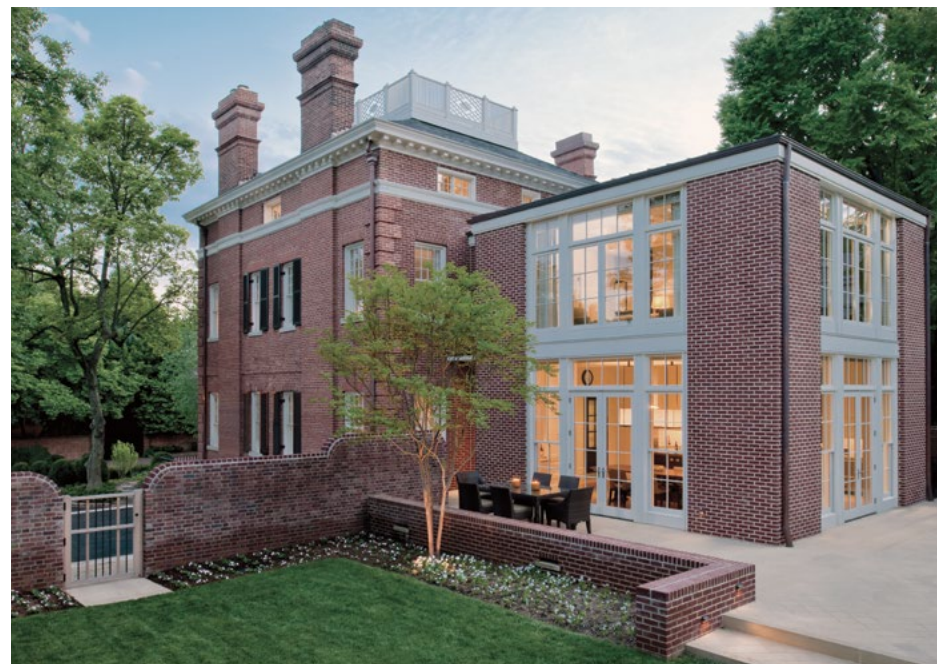
[61 a-b] The materials, design, and location at the back of the historic house are important factors in making this a compatible new addition. Photos: © Maxwell MacKenzie.

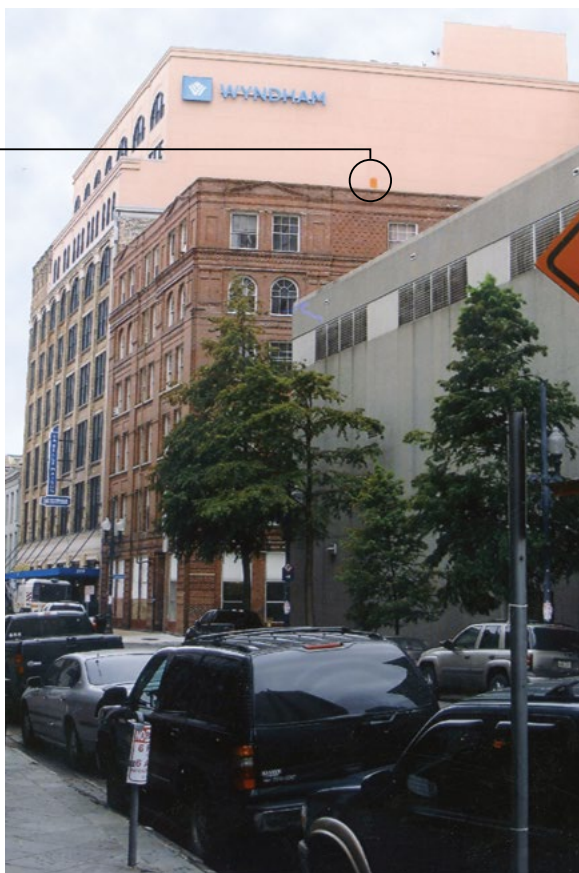
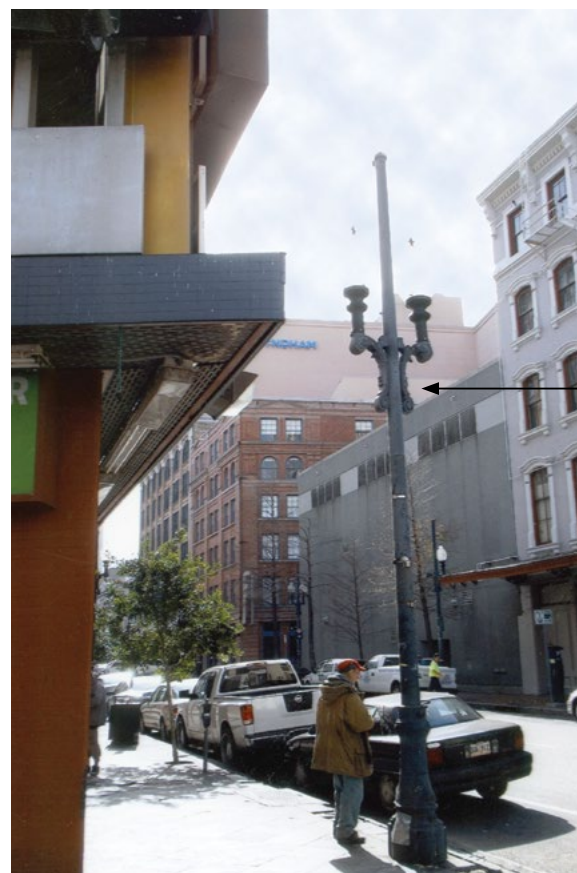
[ 63] (a) A mockup should be erected to demonstrate the visibility of a proposed rooftop addition and its potential impact on the historic building. Based on review of this mockup (orange marker), it was determined that the rooftop addition would meet the Standards (b). The addition is unobtrusive and blends in with the building behind it.

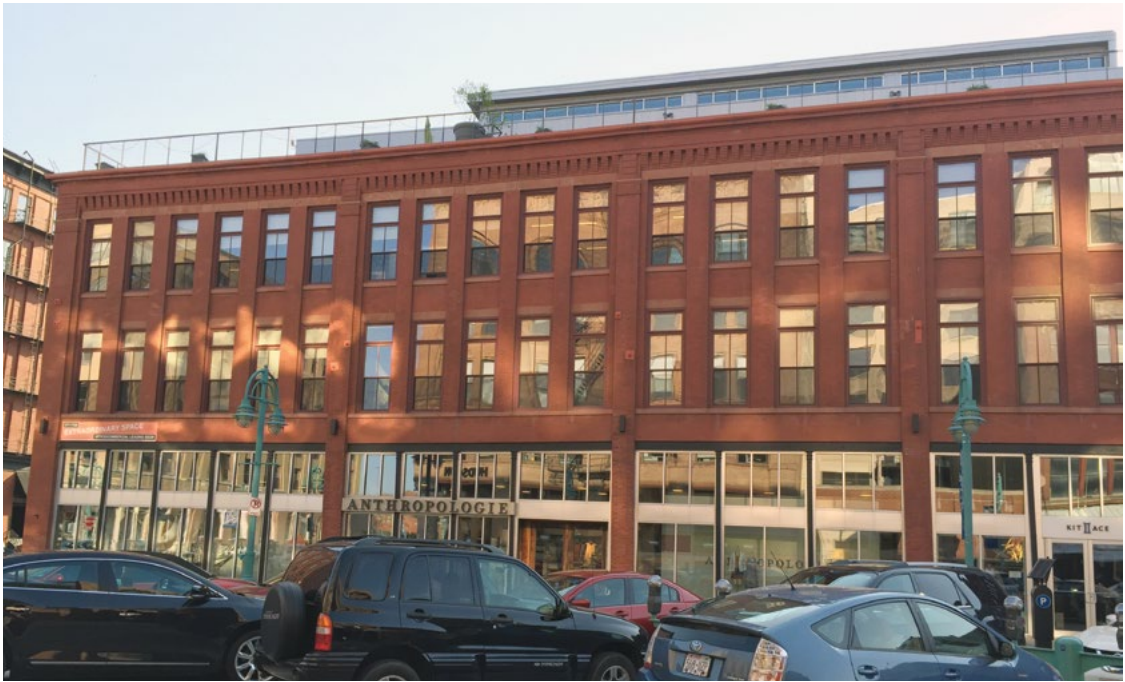
[64] **Not Recommended:**  
It is generally not appropriate to construct a rooftop addition on a low-rise, two- to three-story building such as this, because it negatively affects its historic character.

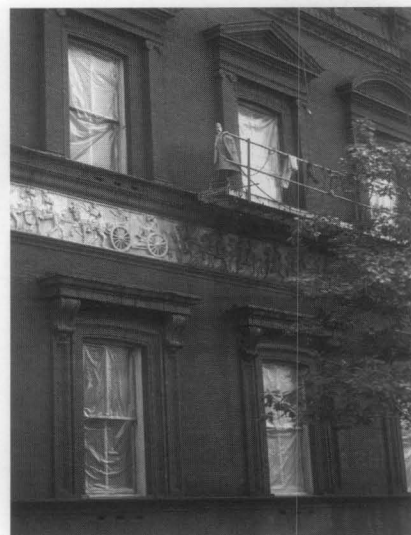
Figure 1. Low-to medium-pressure steam (hot-pressurized water washing), is being used to clean the exterior of the U.S. Tariff Commission Building, the first marble building constructed in Washington, D.C., in 1839. This method was selected by an architectural conservator as the "gentlest means possible" to clean the marble. Steam can soften heavy soiling deposits such as those on the cornice and column capitals, and facilitate easy removal. Note how these deposits have been removed from the right side of the cornice which has already been cleaned.

The Brief is intended to help develop sensitivity to the qualities of historic masonry that makes it so special, and to assist historic building owners and property managers in working cooperatively with architects, architectural conservators and contractors (Fig. 1). Although specifically intended for historic buildings, the information is applicable to all masonry buildings. This publication updates and expands *Preservation Brief 1: The Cleaning and Waterproof Coating of Masonry Buildings*. The Brief is not meant to be a cleaning manual or a guide for preparing specifications. Rather, it provides general information to raise awareness of the many factors involved in selecting cleaning and water-repellent treatments for historic masonry buildings.

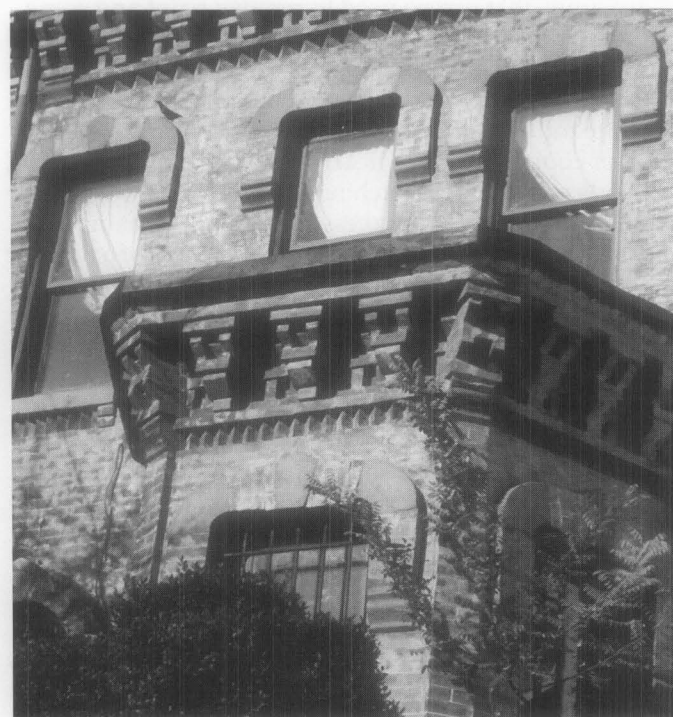
Figure 15. The whitish deposits left on the brick by a chemical paint remover may have resulted from inadequate rinsing or from the chemical being left on the surface too long and may be impossible to remove.

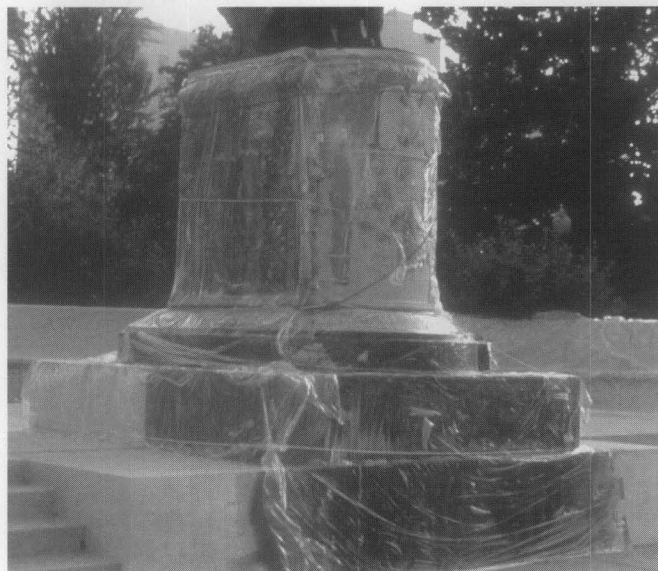
b

Figure 16. (a) The limestone base was heavily stained by runoff from the bronze statue above. (b) A poultice consisting of copper stain remover and ammonia mixed with fuller's earth was applied to the stone base and covered with plastic sheeting to keep it from drying out too quickly. (c) As the poultice dried, it pulled the stain out of the stone. (d) The poultice residue was removed carefully from the stone surface with wooden scrapers and the stone was rinsed with water. Photos: John Dugger.

Graffiti and stains, which have penetrated into the masonry, often are best removed by using a poultice. A poultice consists of an absorbent material or clay powder (such as kaolin or fuller's earth, or even shredded paper or paper towels), mixed with a liquid (solvent or other remover) to form a paste which is applied to the stain (Figs. 16-17). As it dries, the paste absorbs the staining material so that it is not redeposited on the masonry surface. Some commercial cleaning products and paint removers are specially formulated as a paste or gel that will cling to a vertical surface and remain moist for a longer period of time in order to prolong the action of the chemical on the stain. Pre-mixed poultices are also available as a paste or in powder form needing only the addition of the appropriate liquid. The masonry must be pre-wet before applying an alkaline cleaning agent, but not when using a solvent. Once the stain has been removed, the masonry must be rinsed thoroughly.

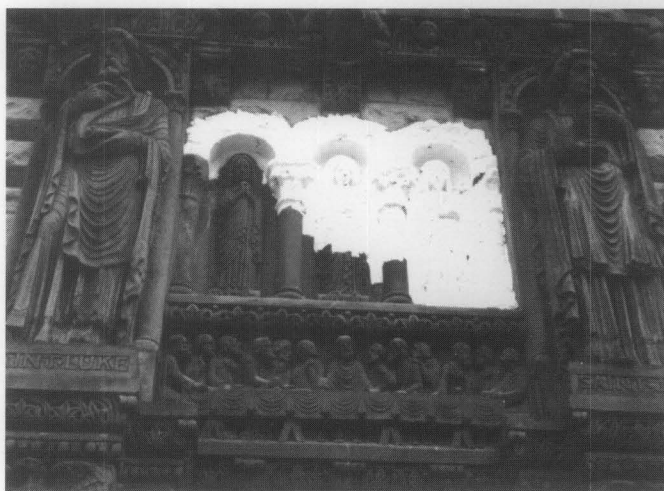
Figure 17. A poultice is being used to remove salts from the brownstone statuary on the facade of this late-19th century stone church. Photo: National Park Service Files.

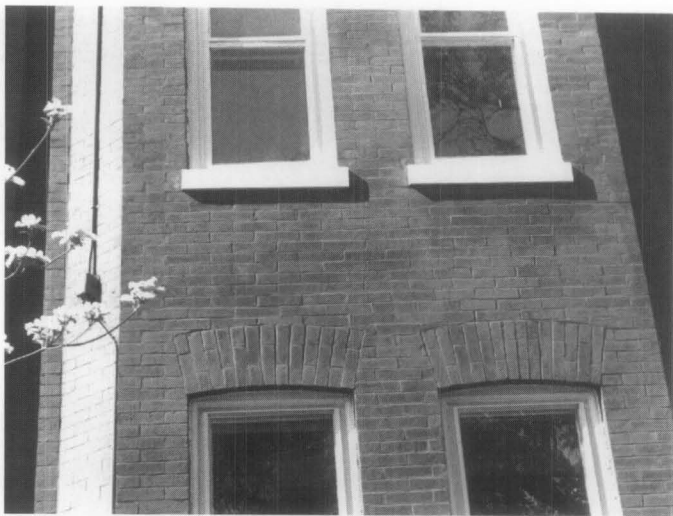
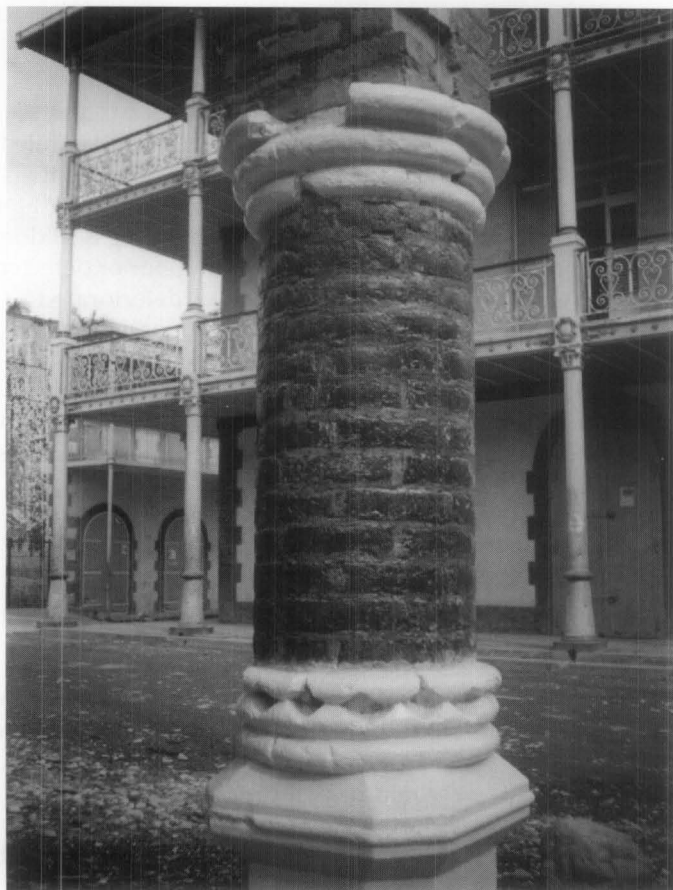
Figure 24. Although the application of a water-repellent coating was probably not needed on either of these buildings, the coating on the brick building (above), is not visible and has not changed the character of the brick. But the coating on the brick column (below), has a high gloss that is incompatible with the historic character of the masonry.

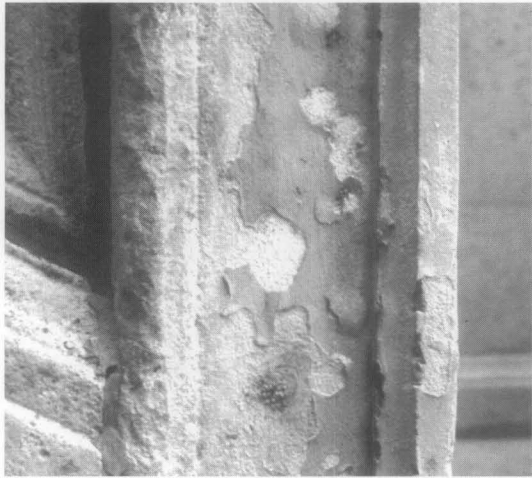
Figure 25. The clear coating applied to this limestone molding has failed and is taking off some of the stone surface as it peels. Photo: Frances Gale.

Some modern water-repellent coatings which contain a binder intended to replace the natural binders in stone that have been lost through weathering and natural erosion are described in product literature as both a water repellent and a consolidant. The fact that newer water-repellent coatings penetrate beneath the masonry surface instead of just forming a layer on top of the surface may indeed convey at least some consolidating properties to certain stones. However, a water-repellent coating cannot be considered a consolidant. In some instances, a water-repellent or "preservative" coating, if applied to already damaged or spalling stone, may form a surface crust which, if it fails, may exacerbate the deterioration by pulling off even more of the stone (Fig. 25).

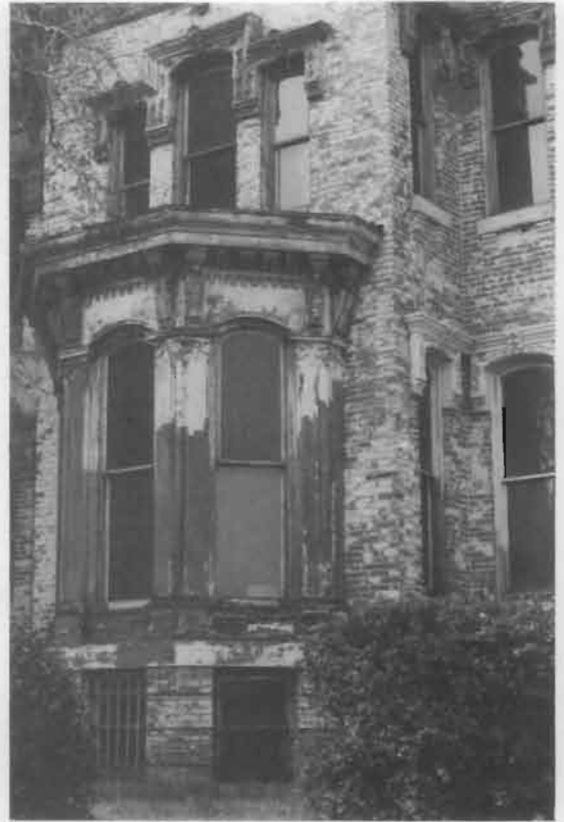
*Figure 3. Know what you are cleaning. If the painted surfaces of the projecting bay window on this once elegant Second Empire brick mansion were still intact, it would not be easy to identify the beltcourse as sandstone, the windows and window frames as wood, and the cornice and all of the window hoods as pressed metal. Cleaning so many different building materials may require a variety of techniques and treatments.*

Indeed, some parts of a building, particularly decorative features, may not be masonry at all (figure 3). Frequently, such features as window hoods, cornices and balustrades may be metal, such as cast iron, galvanized sheet iron or zinc. When painted, they give an intentional appearance of masonry. Some features may have been fabricated of wood, then coated with a sanded paint to give the illusion of sandstone. Thus, the need to correctly identify the type of masonry, or other non-masonry materials on a building cannot be over-emphasized when planning a cleaning project.

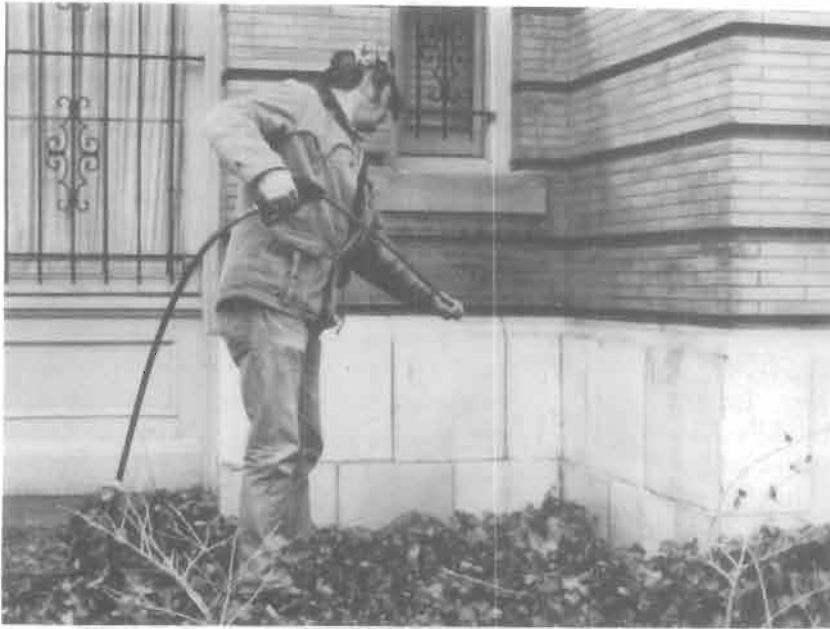
Figure 7. A contractor prepares equipment before testing a low-pressure water wash on a Roman brick and terra cotta building. Photograph: Sharon C. Park, AIA

Because of the wide variety of unforeseeable factors, the cleaning method or methods should always be tested on an inconspicuous area of the building and preferably in more than one location (figure 7). Such tests must be carried out before attempting any large-scale masonry cleaning project. Failure to do so may have disastrous consequences for the outcome of the cleaning as well as the long-term preservation of the historic building material. Testing should be carried out by the consultant or conservation specialist, or by the contractor, under the consul-

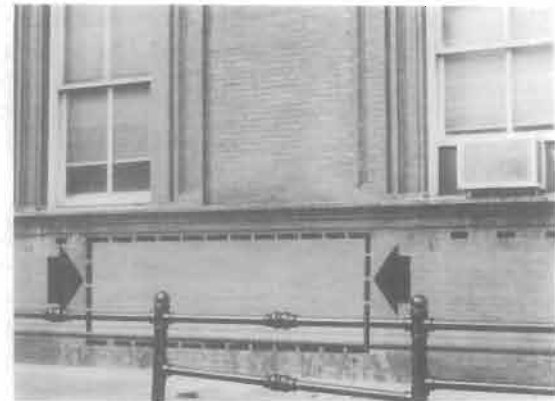
Figure 9. A test patch on brick to remove a century of dirt reveals only a slight difference in appearance between the cleaned and the uncleaned brick. The hard-baked outer skin of the brick provides a surface that is not only impervious to dirt penetration, but resists dirt accumulation. Photograph: Christina Henry

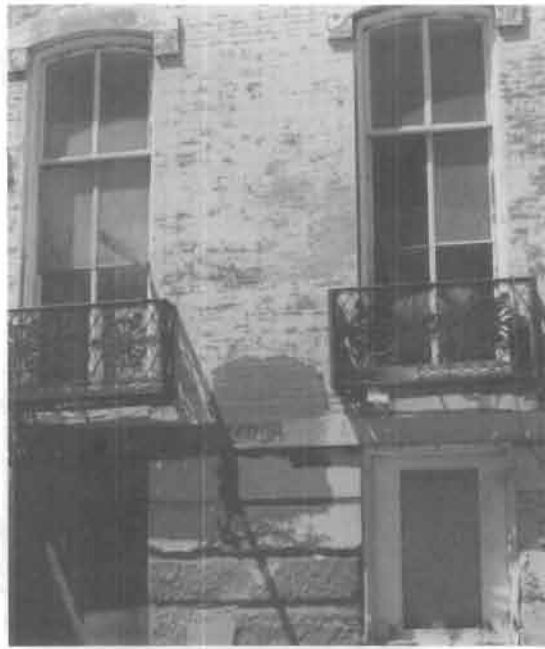
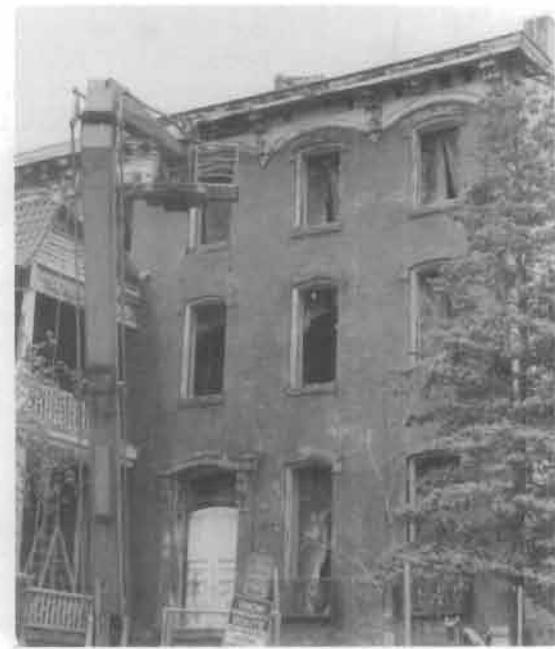
*Figures 10a-10b. This test cleaning patch on brick and sandstone was allowed to weather over a full year, while other aspects of the rehabilitation were carried out. Finally the entire building was cleaned with a proprietary paint remover sprayed-on under low-pressure and then rinsed by workmen from a truck-mounted hydraulic platform lift.*

A test patch should be allowed to weather as long as possible before the cleaning project is begun to give ample opportunity for an accurate evaluation of the results. One year is the preferred amount of time; this allows the patch to be exposed to a complete weathering cycle (figures 10a-10b). If this is not feasible, it is a good idea to

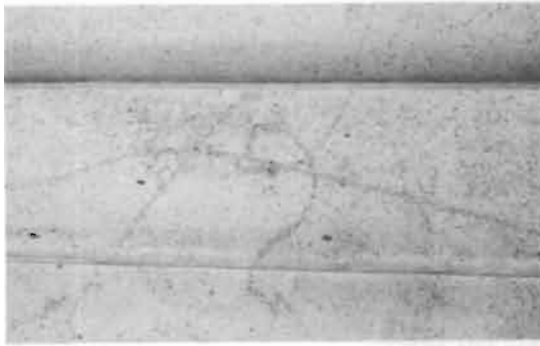
*Figure 12. Water at too high a pressure from a pin-point nozzle has etched this white Vermont granite. Photograph: David A. Look, AIA*

**Cautions and Precautions.** Despite the fact that water washing methods may be the gentlest of all cleaning methods they are not without hazards. Even these methods can be abrasive. Water pressure should always be kept at the lowest level that will clean the masonry without damage. Too highly pressurized water can etch or otherwise scar masonry, and may penetrate through the masonry walls (figure 12).

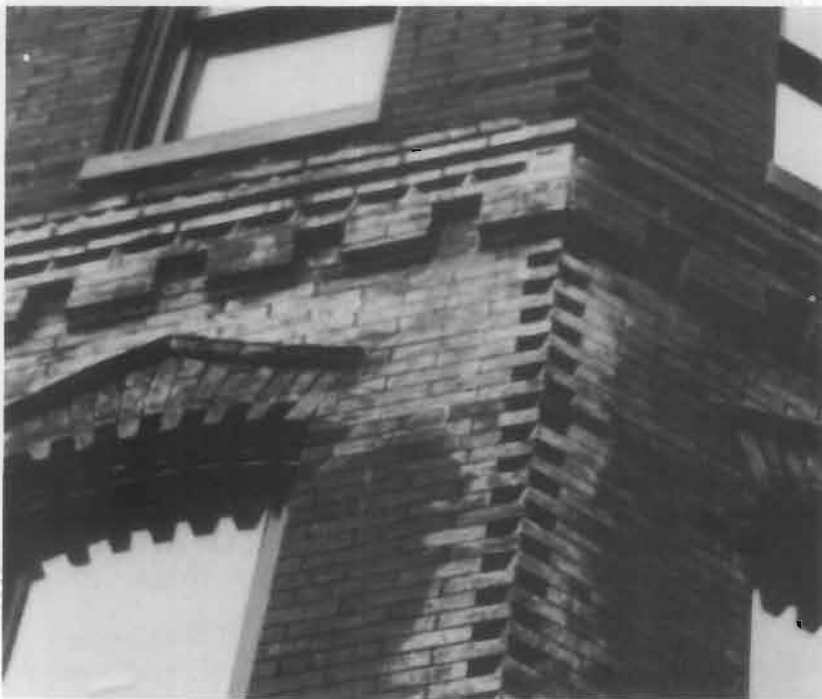
Figure 13. While hydrofluoric acid-based cleaners are often appropriate for cleaning unglazed brick, they may form hard-to-remove whitish silica deposits if left too long on the surface.

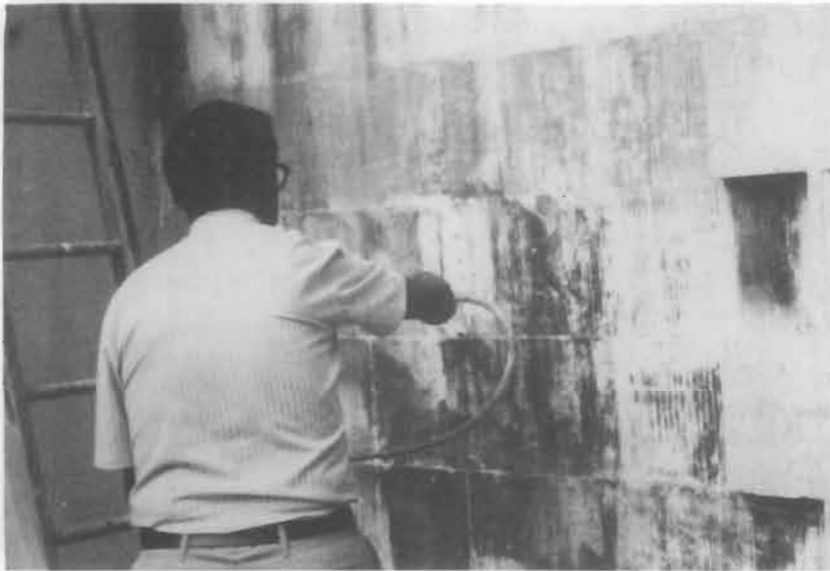
*Figures 15a-15b. If a highly articulated facade is being cleaned it may be necessary to scaffold the building, one elevation at a time. When the monumental task of chemically removing all the paint from the White House was begun, each side was scaffolded in preparation for repainting. Removal of the many layers of paint that had obscured the stone tooling marks for almost a century, without damaging the historic sandstone, required much painstaking hand work.*

generally formulated to remove most types of paint (except cementitious or lime-based paints such as whitewash) from all types of masonry. But it is always preferable to use an alkaline paint remover on acid-sensitive masonry (figures 15a-15b).

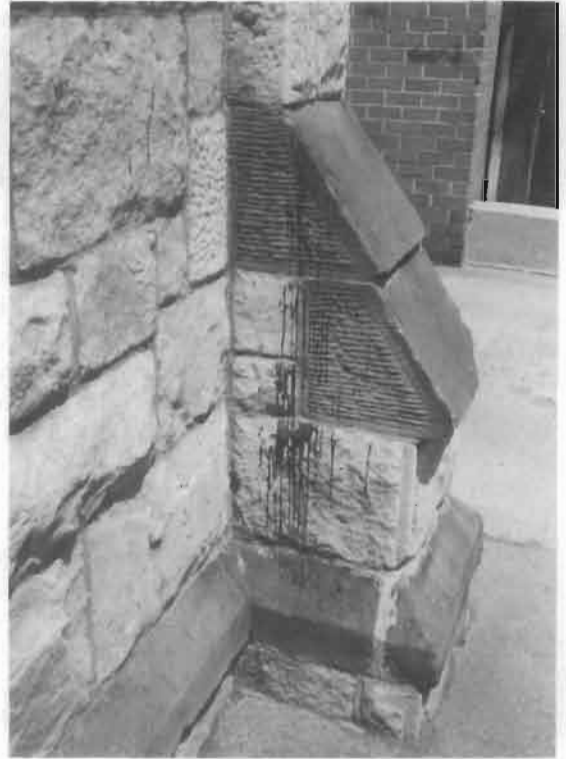
*Figure 19. Efficient removal of tar splatters from limestone and sandstone may be facilitated initially by applying dry ice or carbon dioxide, but complete removal will probably require poulticing with an in-organic solvent.*

Removal of larger chunks of asphalt or tar accumulations may be facilitated by applying dry ice or spraying with carbon dioxide. The asphalt or tar will be embrittled by the dry ice or carbon dioxide, and after tapping with a small hammer, can usually be removed from the masonry surface by prying it up with a putty knife, (figure 19). This same technique can be used for removing gum, adhesives or other sticky substances. Such techniques, however, should not be used on wet masonry, as they may freeze the moisture in the masonry, and cause cracking or spalling. Organic solvents or bleaches are also effective, sometimes in a poultice, on sticky substances.
